10鄰北側靠公路低位河階地(SL65M)滾石調查位置

巡檢日期：2022-07-14

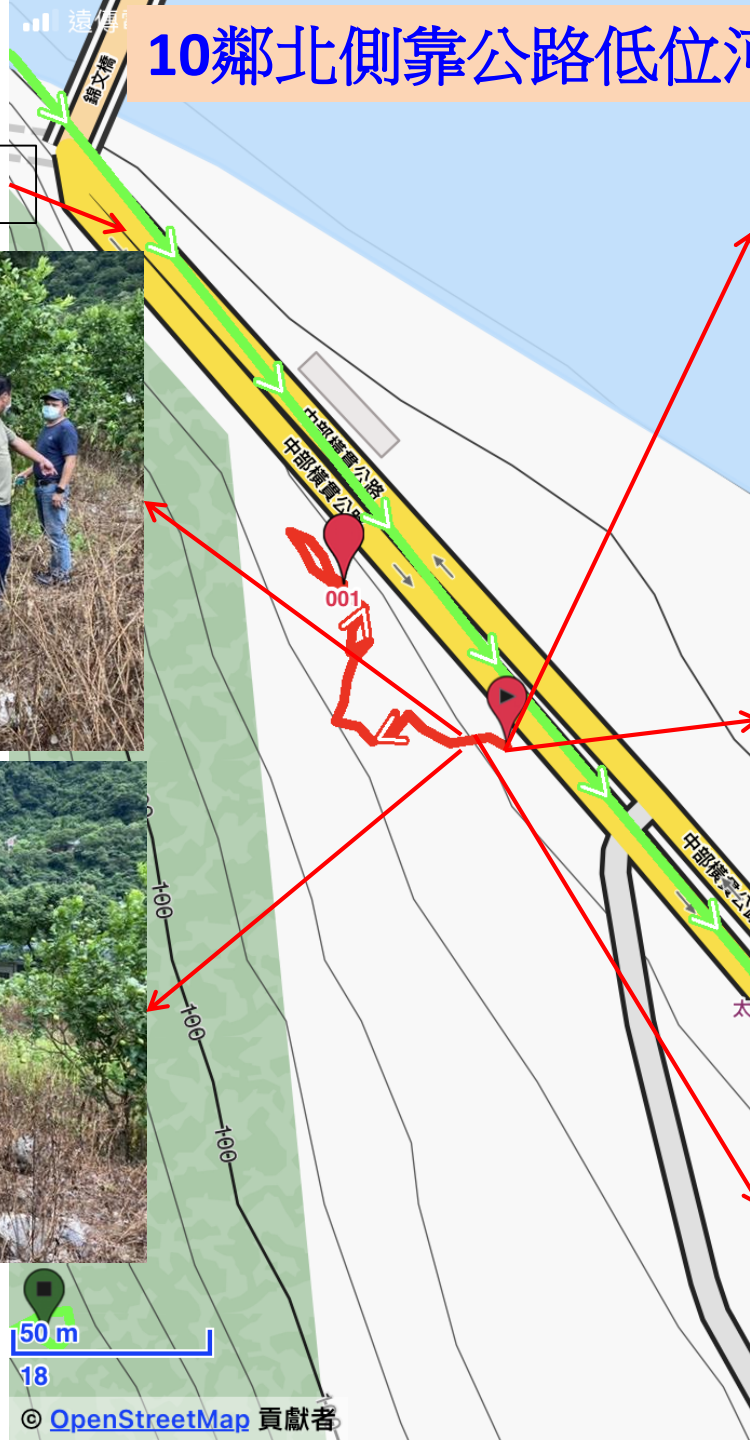
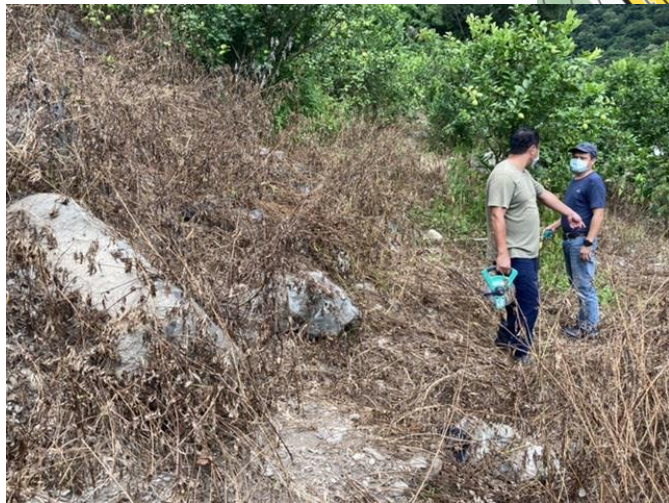
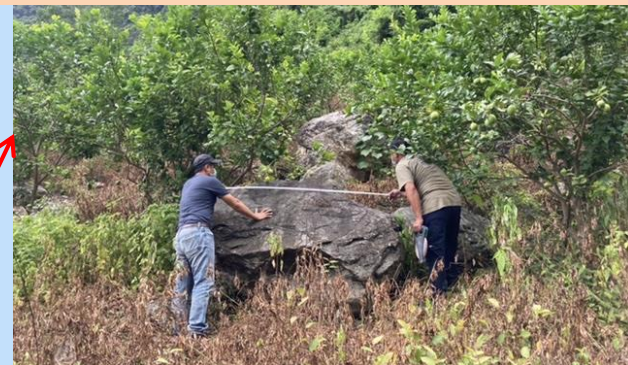
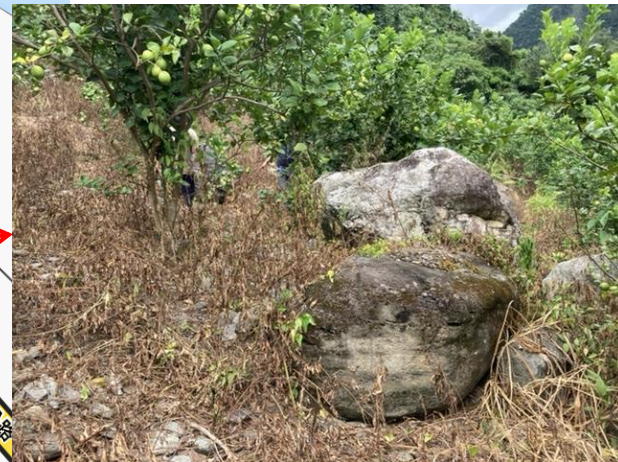
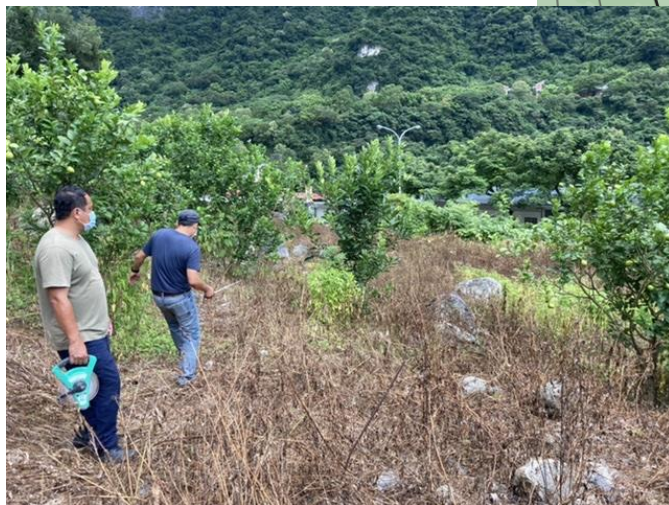
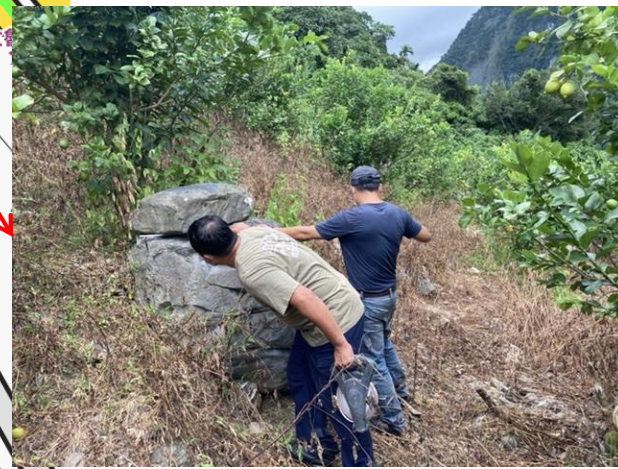
10鄰北側靠公路低位河階地滾石調查記錄(1)

太魯閣牌樓位置

靠太魯閣牌樓之低位河階地上滾石外型沒有稜角，尺寸如下：

長	寬	高	單位:公分
1	230	190	140	
2	230	200	150	
3	100	150	65	
4	150	110	90	
5	150	140	120	
6	280	220	170	
7	160	90	70	
8	180	160	100	
9	130	100	70	
10	130	100	70	
11	130	100	70	
12	280	100	90	埋在土裡面
13	280	100	90	埋在土裡面
14	280	100	90	埋在土裡面

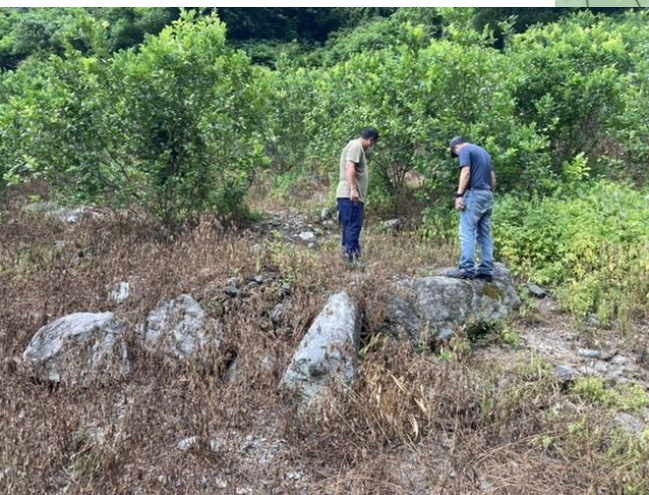
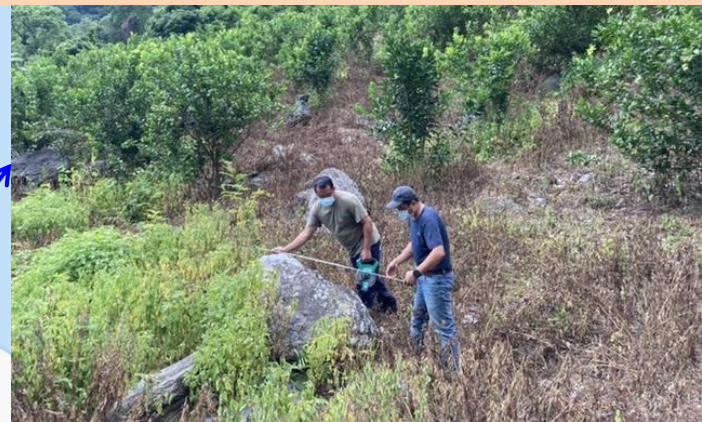
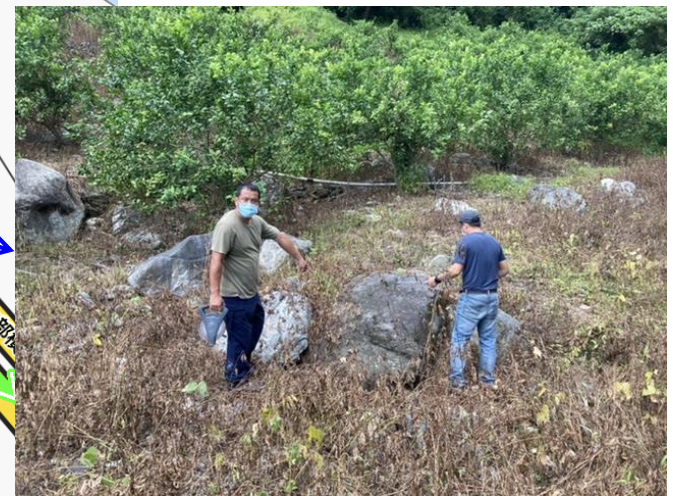
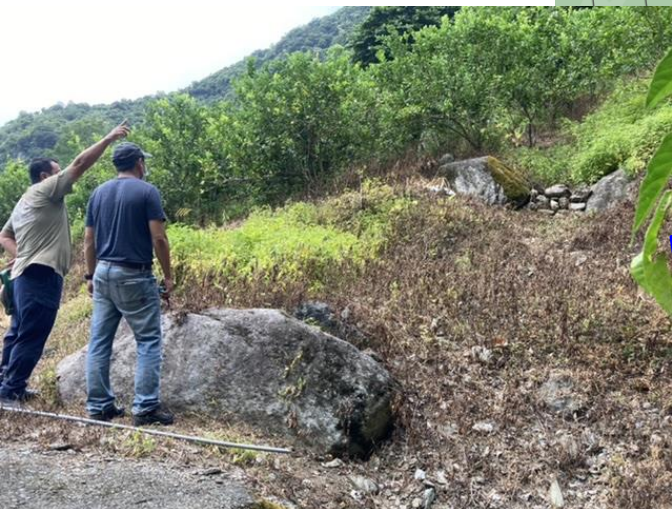
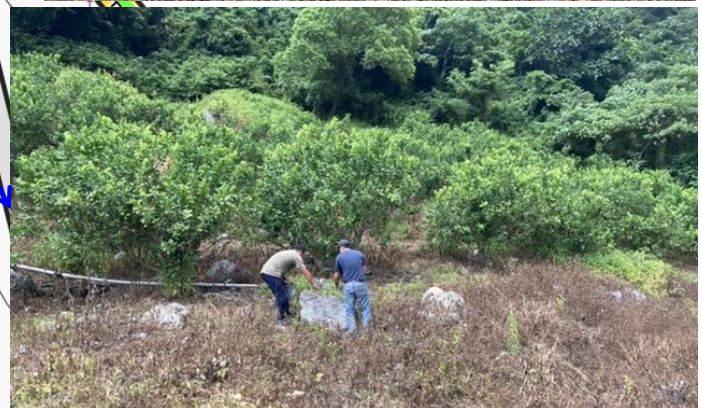
10鄰北側靠公路低位河階地滾石調查記錄(2)

太魯閣牌樓位置

2022-07-18經向鄰近住家(273號)、該土地種檸檬地主、對面雜貨店、烤香腸店家訪查，說：「未曾有過落石或地震落石發生，該土地上之滾石古早就存在」。
